DEPARTMENT OF TRANSPORTATION**DIVISION OF ENGINEERING SERVICES**

Contract #: 04-0120F4Cty: SF/ALA Rte: 80 PM: 13.2/13.9File #: 69.28**WELDING INSPECTION REPORT****Resident Engineer:**Pursell, Gary**Address:** 333 Burma Road**City:** Oakland, CA 94607**Report No:** WIR-013081**Date Inspected:** 26-Mar-2010**Project Name:** SAS Superstructure**OSM Arrival Time:****Prime Contractor:** American Bridge/Fluor Enterprises, a JV**OSM Departure Time:****Contractor:** Zhenhua Port Machinery Company, Ltd (ZPMC), Changxing Island **Location:** Shanghai, China

HEAVY DOCK

LIFT:6 East/West and Crossbeam(CB)-CB6.

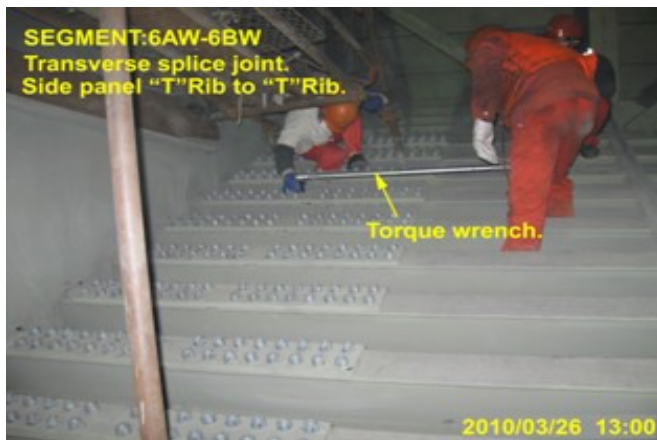
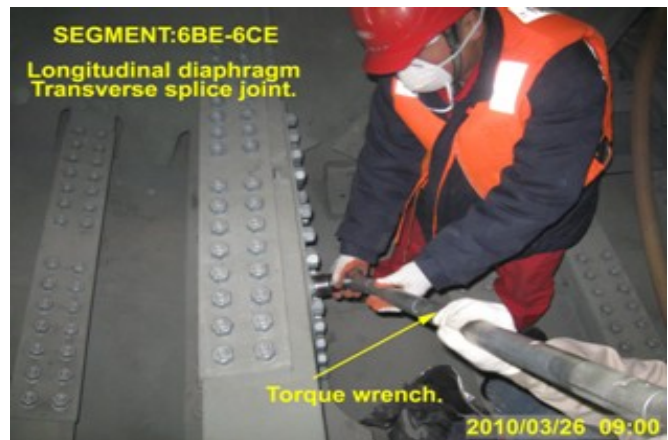
This Quality Assurance (QA) Inspector witnessed final tension verification for the Bottom Panel (BP) "T"Rib to "T"Rib splice joints, Side panel(SP) "T"Rib to "T"Rib splice joints, Longitudinal diaphragm(LD) to Longitudinal diaphragm splice joints and Cat walk supports at LIFT:5 6 East/West and CB6. Inspected 10% on a random basis and found the tension to be in general compliance. Inspection was performed against the ZPMC submitted Notification No. 00305 Dated: March 26, 2010.

The attached photograph provides additional detail.
